Title: **STRENGTHENING OF REINFORCED CONCRETE BEAMS USING GLASS FIBER REINFORCED POLYMER (GFRP)**

Volume 09, Issue 07, Pages: 92-100

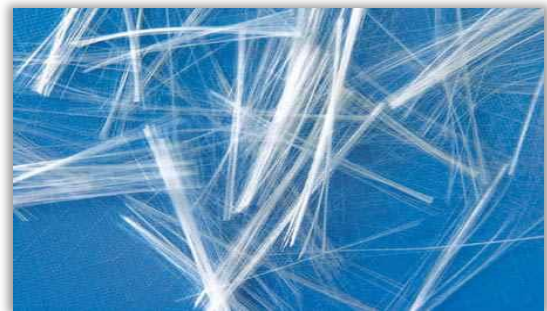
Fig. 2: Threads of glass fibre

corrosion resistant structures due to its mechanical properties. Glass containers are used to handle corrosive chemicals and see little or no effect of the media on the container. Research shows no loss of laminated properties of GFRP even after 30 years. In load bearing, the choice of glass fibre is crucial for the long term structural performance of the composite. A number of choices of different glass fibre types are available but not all are suited for corrosive environments. Figure 2 shows thin threads of glassfibres.
